Modifications to MTH Center Roller
Mark DiVecchio (SanDiegoMark)
12 March 2017

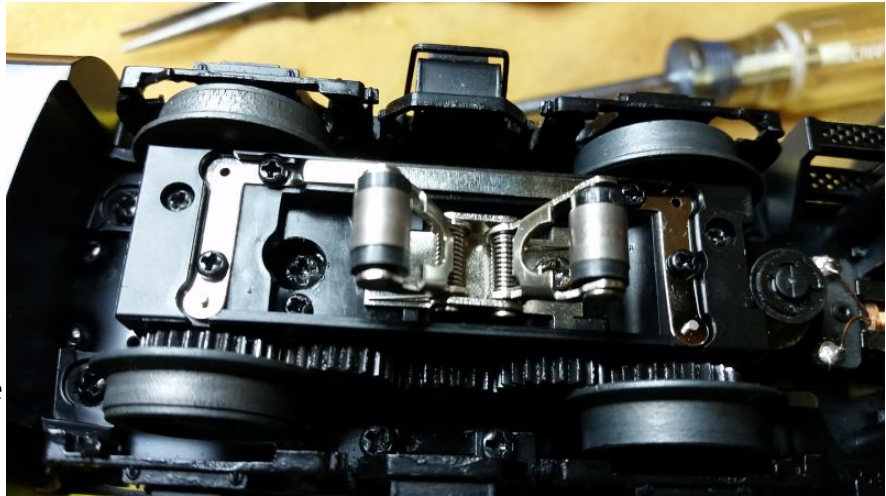
Here is a photo of typical truck. When I press down on the center roller, I can see that the outside roller (on the right in this photo) was not retracting all the way. It was hitting something.

I also noticed that if I pressed the roller hard enough, it actually locked in to the retracted position. I could sight along the roller and see that the roller (when retracted) was lower (toward the track) than a line between the treads of the two outer wheels.

So it seems like the roller retracts as far as it can, which is not enough and then the entire truck is raised up off the track.

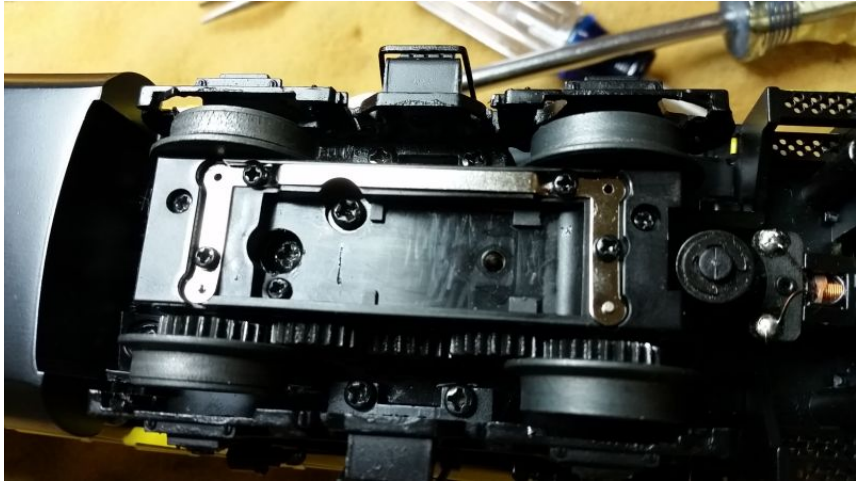
I could see plastic nubs that helped to align the roller assembly.

There are four nubs. By examining the truck, I could see that the roller on the right was hitting the two right side nubs. The left roller was positioned a little differently so that the left roller did not hit the left

nubs. The left nubs were important in aligning the roller assembly but the right nubs did not seem to be needed as the single screw on that end would serve to align the assembly.

So I removed the right side nubs.

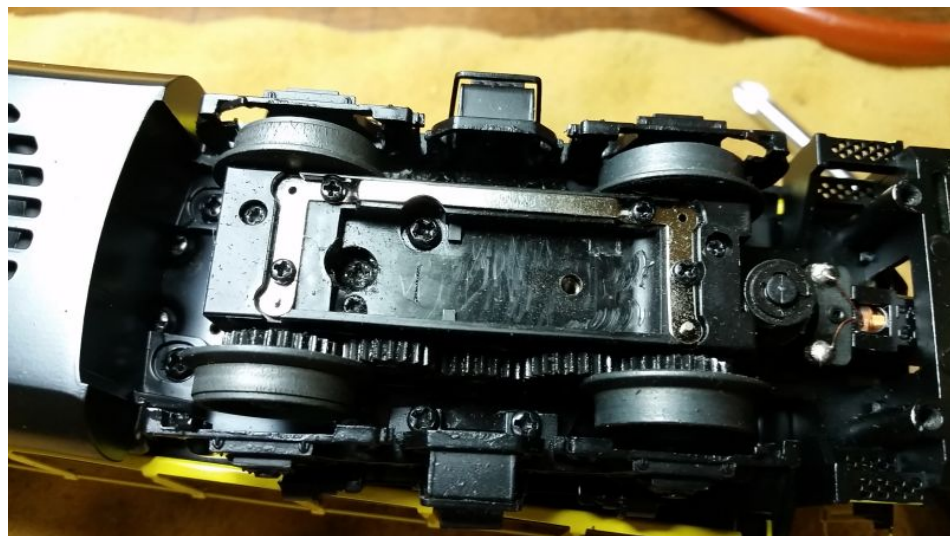
This shows the right side nubs removed.

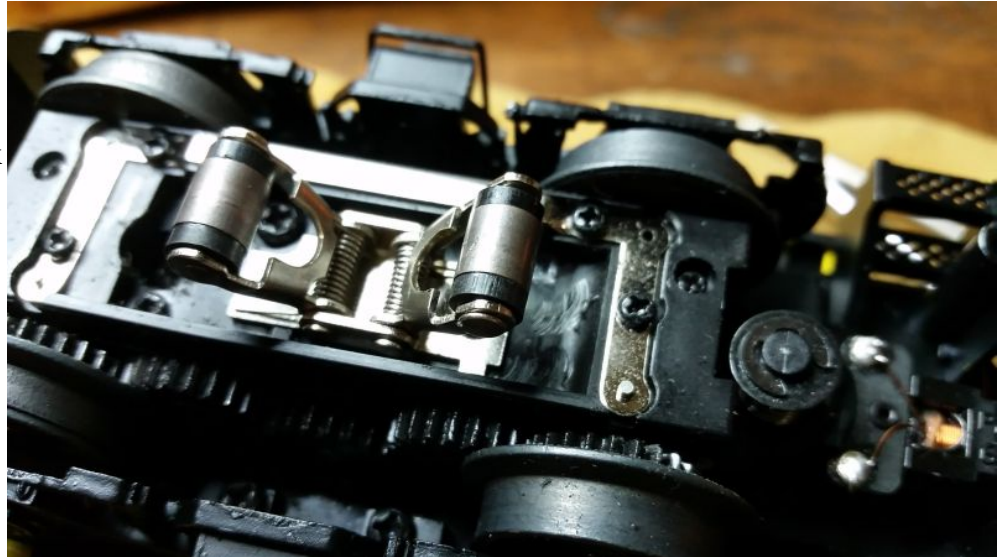
I reinstalled the roller assembly with the single screw. Now the right side roller depresses further and does not lock into place.

Operation on my layout is much better now.

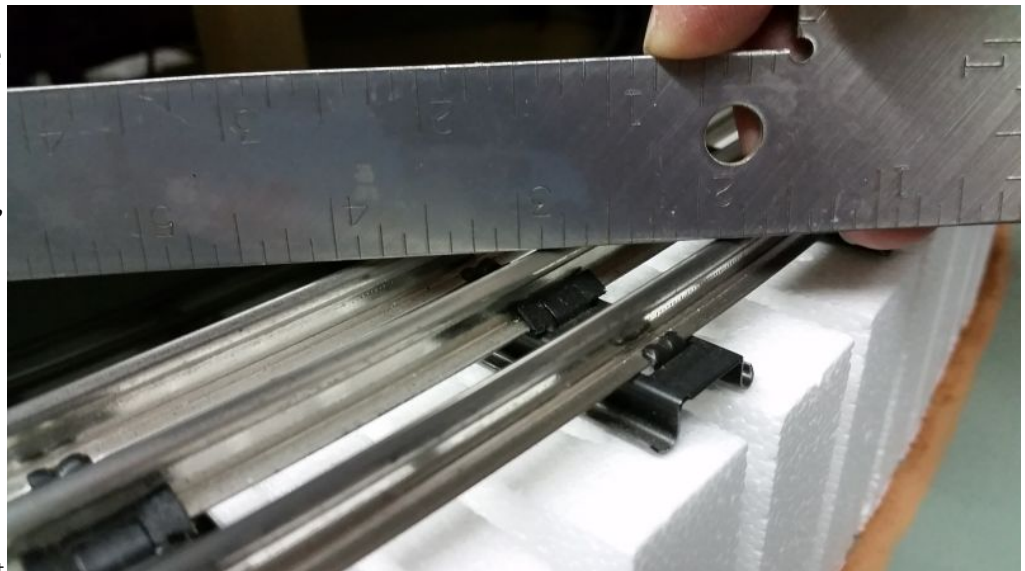
This photo shows the unevenness between the outer rails of tubular track with respect to the center rail. On the sections that I looked at, the center rail was between 1/32" and 1/16" higher. Makes sense since the center rail is raised by the thickness of the insulation.
