MTH GP7 Outside Rail Power Pickup Improvement
Mark DiVecchio (SanDiegoMark)
4 Jul 2020

I have two MTH GP7 diesels (20-20246-1) lettered for my railroad of choice, the Pittsburgh & Lake Erie. My layout uses postwar style tubular track and RossPlate switches.

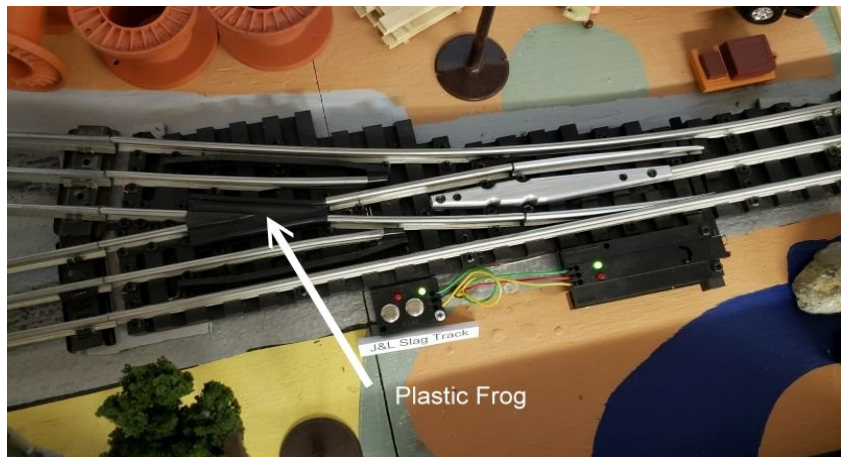
Then, when going over a switch track with a plastic frog (like the RossPlate switches), one of the remaining wheel is on the plastic and thus not in contact with the outer rails.

This leaves ONE wheel to get power to the motor. On my layout, I saw that the one wheel (not on the plastic) raised up slightly and lost contact with the outer rail. The engine lost power and stopped. Sometimes when the engine was going fast enough, it just hiccuped, coasted a bit and then kept on going. But it was a very noticeable jerk.

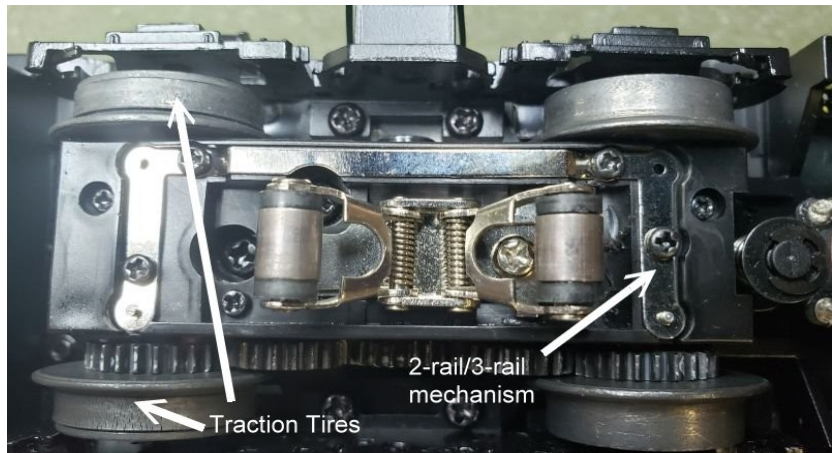
Here is a typical truck on the GP7. There are two traction tires, two full metal wheels and the unusual 2-rail/3-rail powering buss bar. These engines have a switch that lets you run them as either 2-rail or 3-rail engines. I have the switch in the 3-rail position.

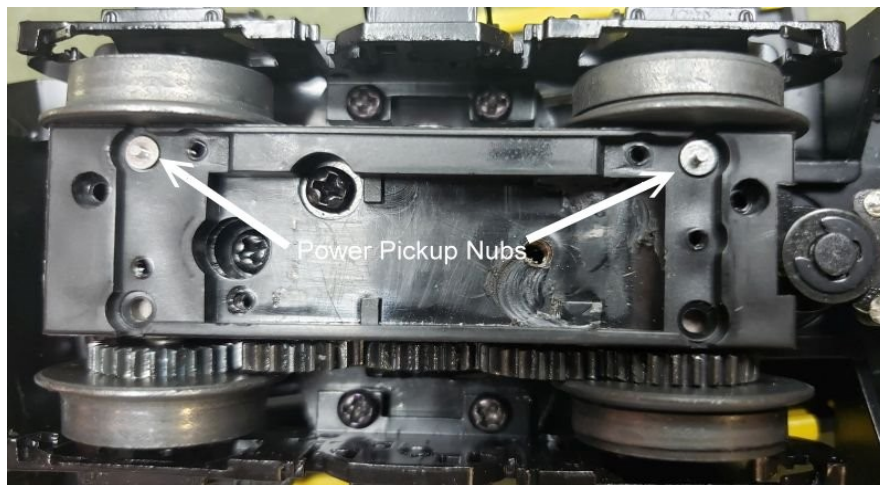
I removed the center rail rollers and the 4 screws holding the buss bar. Here is a photo what I saw.

Underneath the metal bus bar are two power pickup nubs. On this truck, they are in the bottom position (Sorry that the photo does not show this exactly – the nubs can be moved and I was already playing around with that.) The nubs just sit in a hole in the plastic. You can grab them with needle nose pliers and just lift them out.

The nubs transfer outer rail power from the wheels/axles to the buss bar.

But you can see in the earlier photo that there is a power pickup nub contacting the power pickup point of the traction tire axle. This may be true on every diesel engine type so this fix may apply to other engines as well.

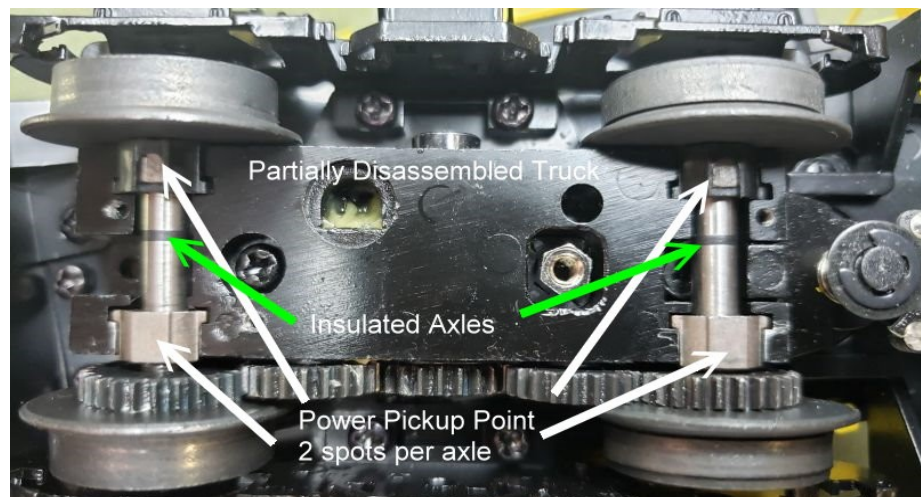
I removed three more screws and then lifted off the plastic part of the truck. In this photo I've exposed the insulated axles and I show the four points where outer rail power can be picked off by the nubs.

Having a power pickup nub on either point of the

traction tire axle is useless. Since the traction tire insulates the wheel from the track, there is never any power at that pickup point.
