Modifications to MTH Center Roller
Mark DiVecchio (SanDiegoMark)
12 March 2017

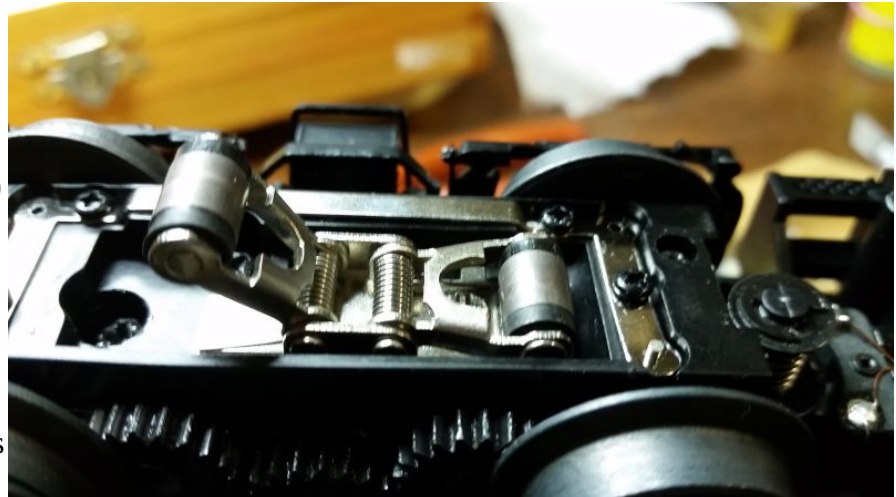
I unscrewed the one screw holding the roller assembly on the truck and removed it.

I could see plastic nubs that helped to align the roller assembly.

There are four nubs. By examining the truck, I could see that the roller on the right was hitting the two right side nubs. The left roller was positioned a little differently so that the left roller did not hit the left

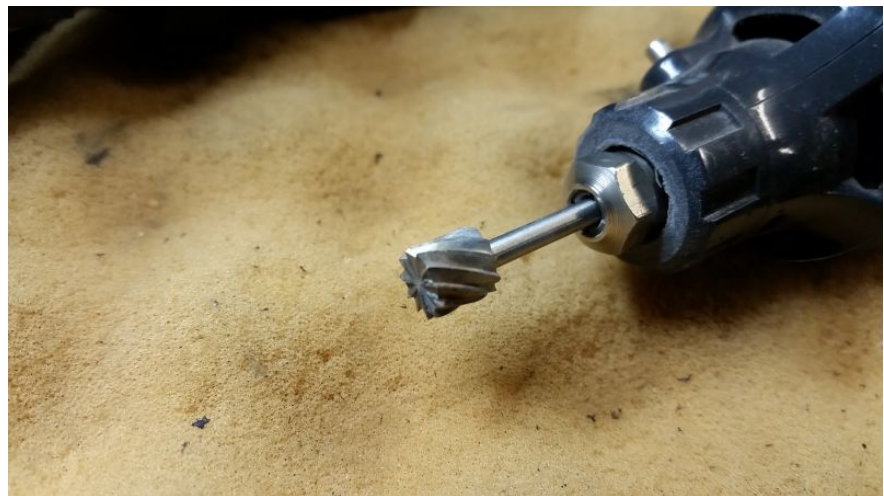
nubs. The left nubs were important in aligning the roller assembly but the right nubs did not seem to be needed as the single screw on that end would serve to align the assembly.

So I removed the right side nubs.

I grabbed my motor tools and a cutting bit. The nubs were plastic so they should be easy to remove.

I removed them.
